Phase 1 Environmental Site Assessment

**Hamachek Klockner Property
97 Ellis Street
Kewaunee, Wisconsin 54216**

Ayres Associates Project No. 53-0516.00

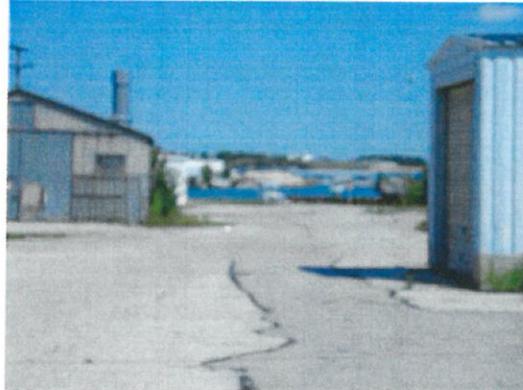
The parcels are mostly level, although a small, somewhat lower lying area was observed just west of the main building and southeast of the Butler building on the northern parcel. This low-lying area is said to hold water during wet weather and is also where historically, workers reportedly dumped containers of hydraulic oil. At the time of Ayres Associates site visit, the City of Kewaunee was suffering from drought conditions (as little as 0.25-inch of rain this season). Although very little healthy vegetation was visible, we are uncertain whether that is owed more to the weather or suspected contamination. Much of the grounds are covered with either deteriorating pavement or sand and gravel.

Between Butler and Main Building north of Ellis

The subject property is an open, yet apparently inactive, Environmental Repair Program Site. A low-lying area between Butler and main building on north side of Ellis Street was reportedly the site of historic dumping of hydraulic oil. Soil and ground water beneath the wooden floors in the northern section of the main building should be tested for releases. Handling of paints, solvents, lubricants oils, and petroleum as well as the metal fabrication operations on this site suggest site wide testing of soils and ground water on the subject property would be prudent. Although some testing has been done on the subject property, Ayres recommends testing and/or retested to confirm findings or determine type and amount of contamination, and remediation strategies. All necessary measures should be taken to address potential concerns in preparation for closure by regulatory agencies.

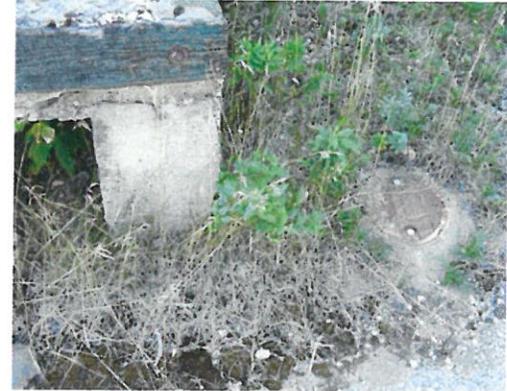
Monitoring well outside of quonset

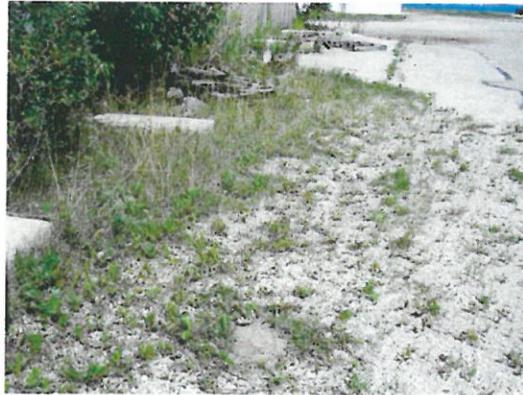
Stressed vegetation on property

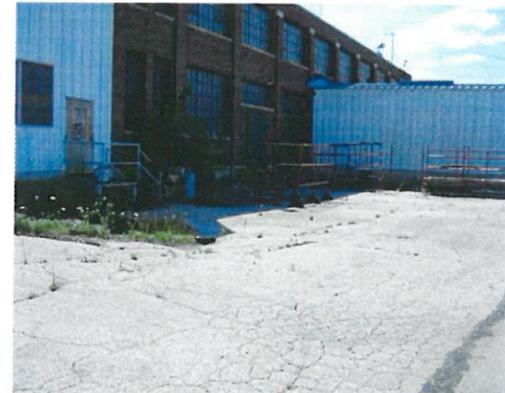
Deterioration pavement

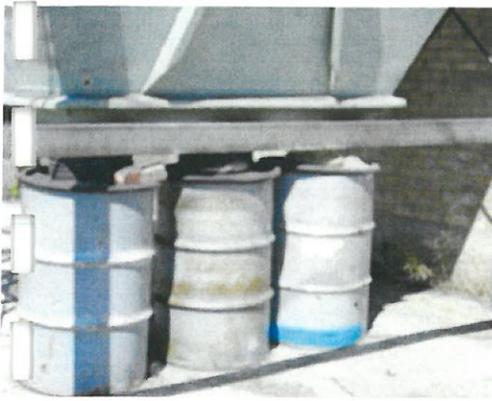
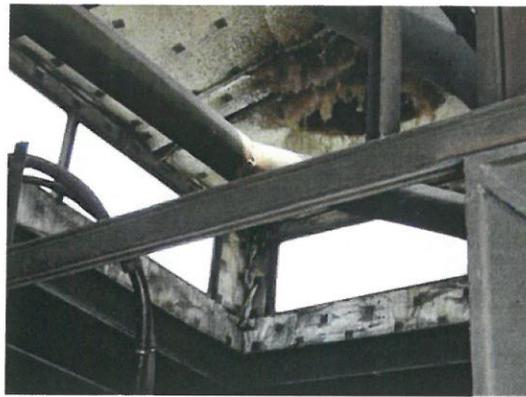
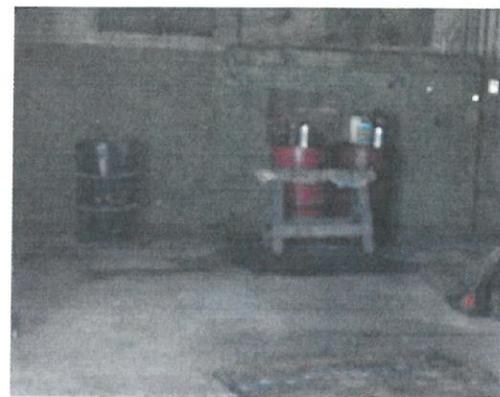
Storage and use of hazardous materials were observed on the subject property. Since the facility has ceased operation the owner has had all containers of chemicals, solvents, oils, etc. gathered into one area of the main manufacturing building located on the northern side of the subject property. Here Ayres Associates observed approximately seventy-five 55-gallon drums along with some smaller drums and buckets. Some are labeled, although not always accurately. In addition Mike Stangel, City of Kewaunee, reported that he had removed and disposed at a local landfill, large amounts of sand/slag from the property both inside buildings and outside. This property has been in use as a metal manufacturing facility for more than 100 years. In the late 1800's and early 1900's, chemical handling was much less stringent than it is today. A former employee of this facility, who does not wish to be named, reported that years ago the disposal practices for hydraulic oil and solvents or chemicals included dumping buckets outside the building in gravel or parking areas.

Photographs of Main Building on North side of Ellis Some of the drums and buckets are labeled but not accurately

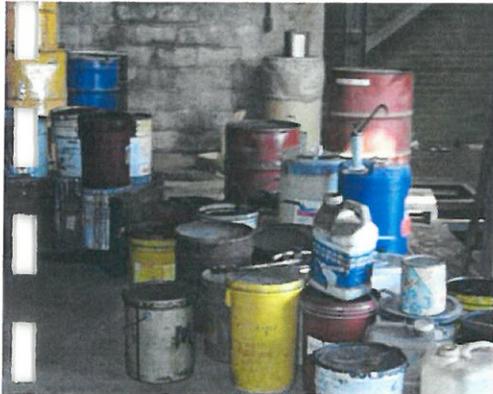
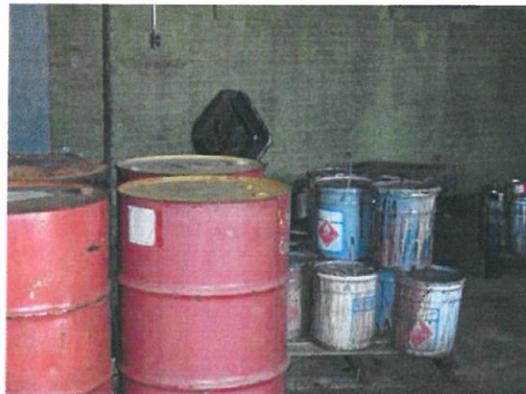
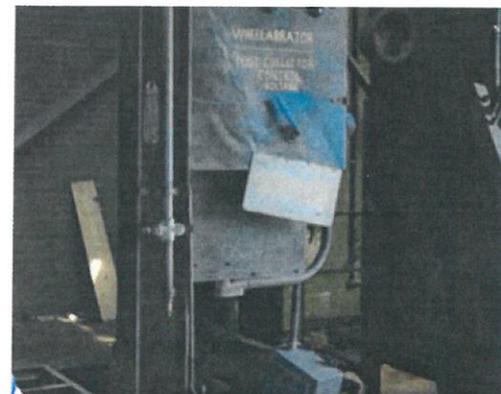
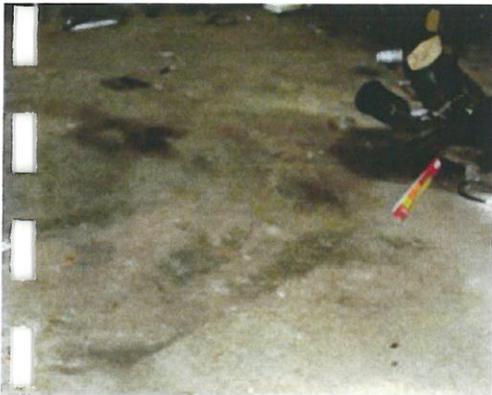
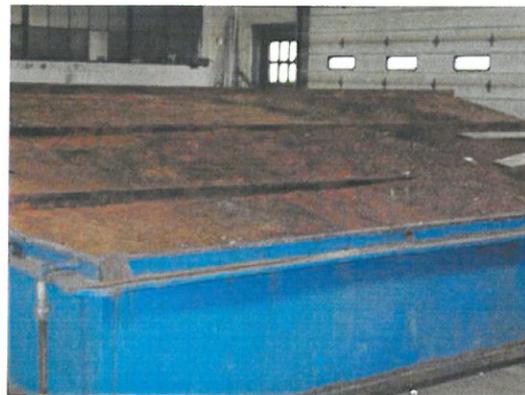
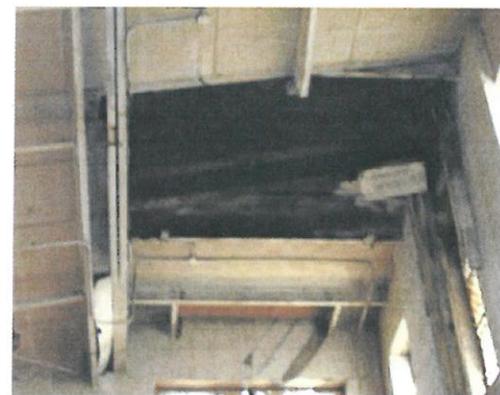
Interior photographs of Main building on North side of Ellis (spills, rust, mold, metal shavings, asbestos, peeling paint)

Peeling paint (possibly lead based) is present on doors located along the public sidewalk leading to the Lake Michigan shoreline. This paint constitutes a possible human health issue. Ayres recommends removing this paint following regulatory agency guidelines.

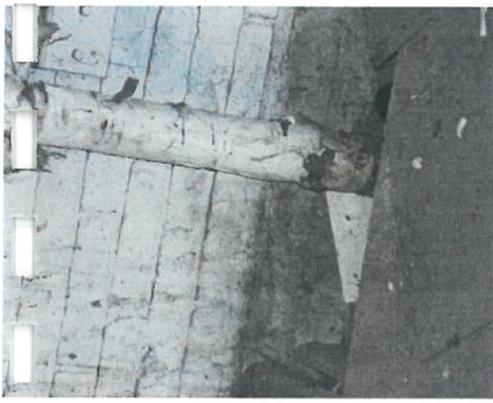
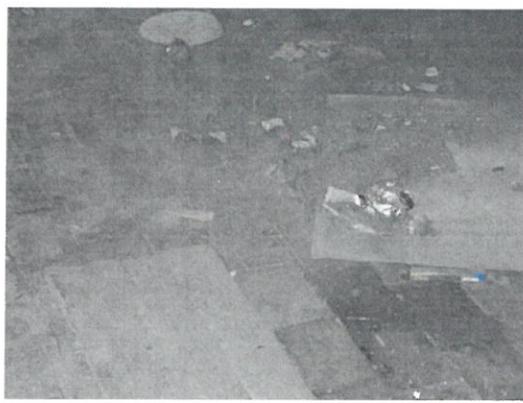
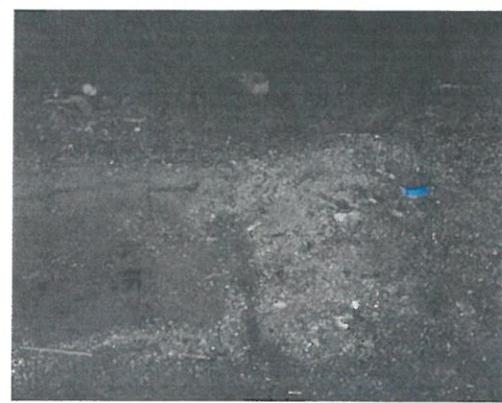
Interior of Main building north of Ellis (asbestos, manufacturing waste, spills, old leaking machinery, deteriorating wood floors)

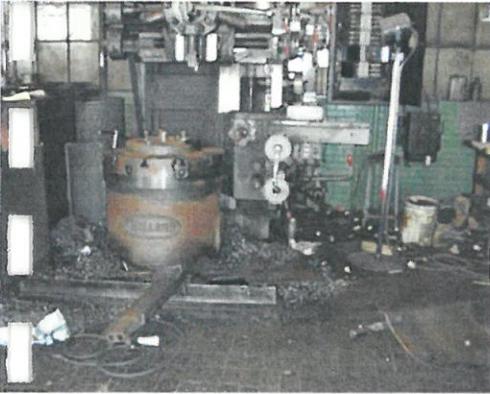
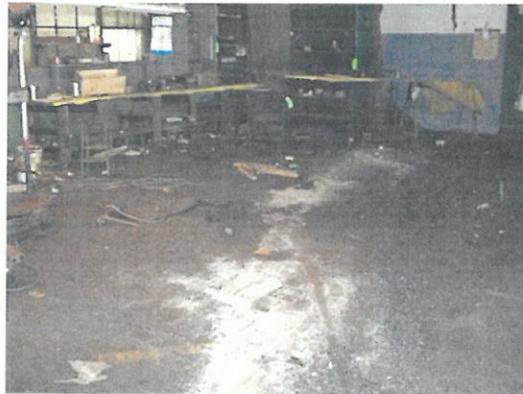
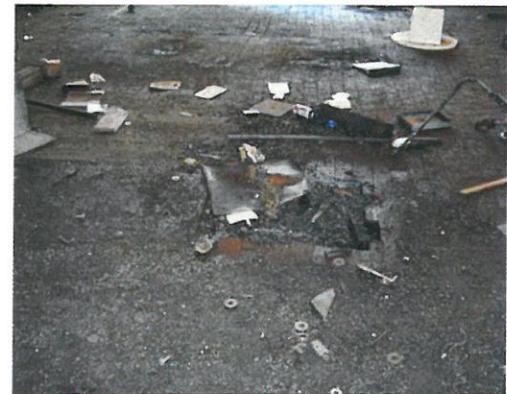
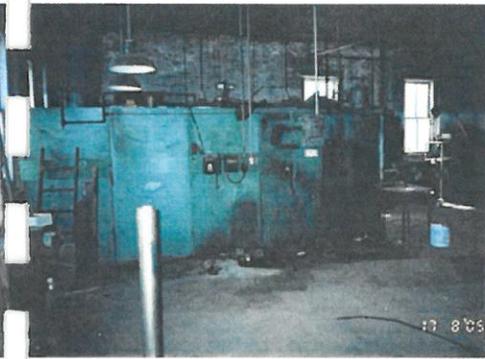
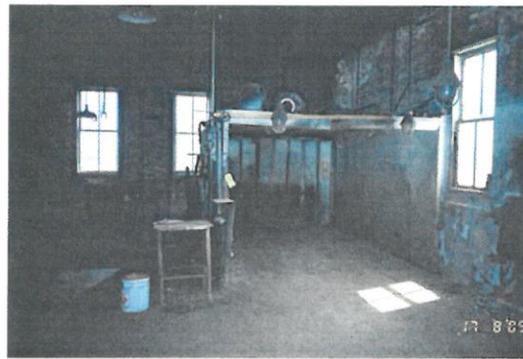
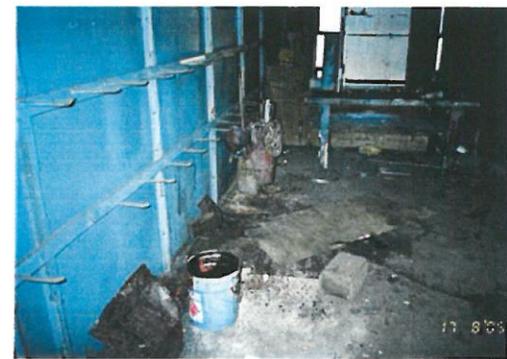
The main building on the subject property is a two-story structure with a partial basement. Although irregular in shape, it measures approximately 200 by 300-feet. This building has been used for manufacturing, storage, and painting. It also contains several offices on both floors. The northern half of this building has deteriorating concrete floors, which show evidence of a former smelting operation. There is no basement beneath this section. The southern half of this structure has a second floor with wooden floors. This space was mostly used for storage and the manufacture of tarps. The basement, which contains three sumps, only one of which is still working, was mostly used for storage. Large portions of the first floor of this building contain floors made up of sawn boards, placed on end to form a sort of tile. This building contains numerous windows and pipes that may contain lead paint and/or lead based paints. All floors in this facility were stained with oil, water, dried powdered paint, and potential solvents. Ayres observed a three quarters full, open, 55-gallon drum of oil (reportedly hydraulic oil) during the walkover.

Interior of Main building north of Ellis (paint booths, manufacturing waste, stained floors, hydraulic oil, basement sumps with oil visible)
